Subject: MIL COMES ON WITH DTC P2006 (VARIABLE SWIRL CONTROL SYSTEM SHUTTER VALVE STUCK CLOSED)	Bulletin No: 01-010/07
	Last Issued: 03/01/2007

2006-2007 Mazdaspeed6

2007 Mazda CX-7

2007 Mazdaspeed3

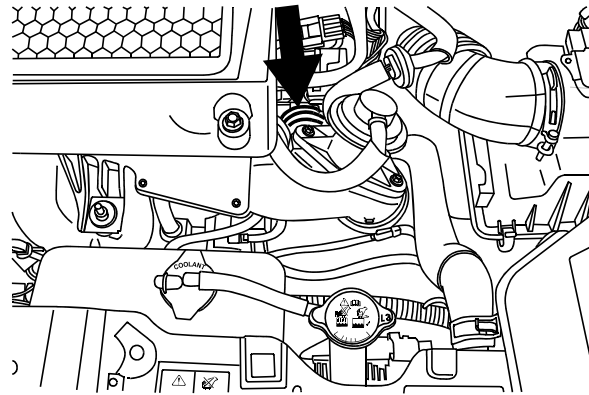
1757a

On some vehicles, the MIL comes on with DTC P2006 stored in memory due to the variable swirl shutter valve actuator sticking intermittently in cold weather. This is caused by inadequate spring force in the actuator. To ensure the valve opens, the spring force of the actuator has been increased.

Customers having this concern should have their vehicle repaired using the following repair procedure.
